# Grove Park Canal Retaining Wall Assessment

WALLACE  
MONTGOMERY

**May 5, 2025**

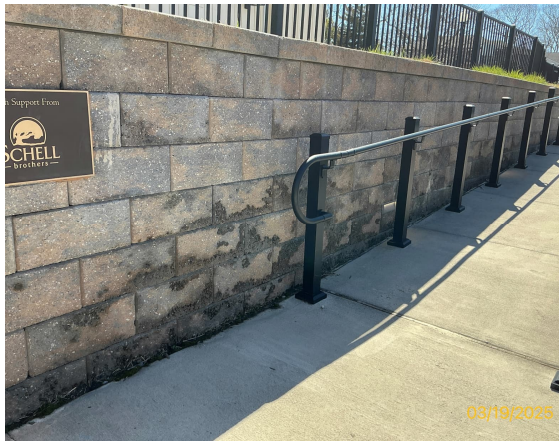
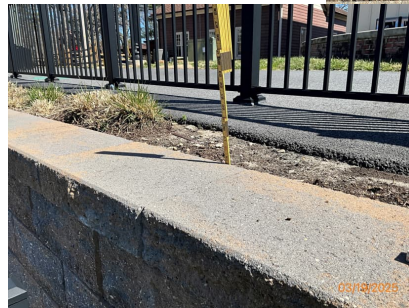
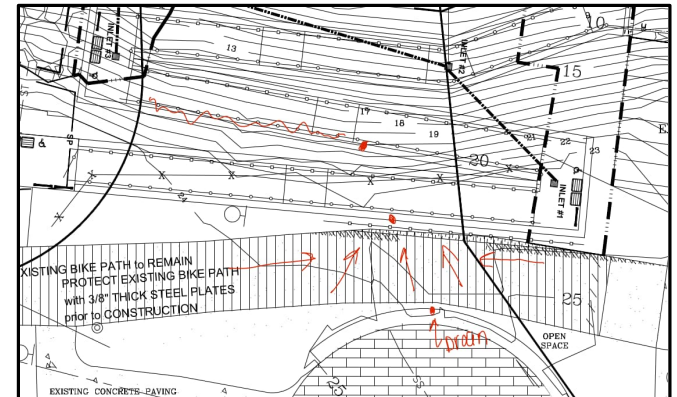
- Moisture staining along the bottom half of Wall #3 adjacent to Walkway #1 and Walkway #2.
- Backfill loss/erosion that can be probed along the northeast most end of Wall #3.
- Bike path and Rehoboth Museum drainage is directed towards the retaining wall.

- Regrade area/divert drainage at the top of the wall
- Seal cracks in the concrete walkway adjacent to Inlet #3

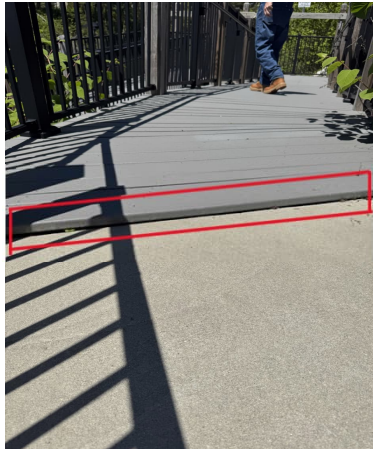
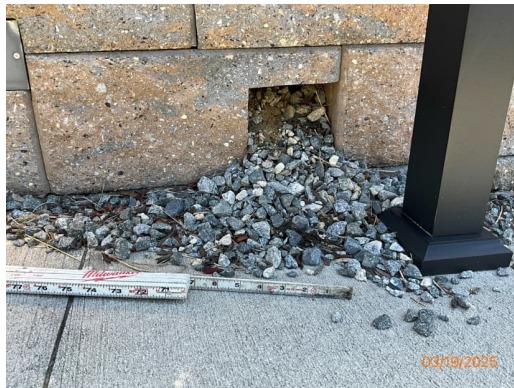
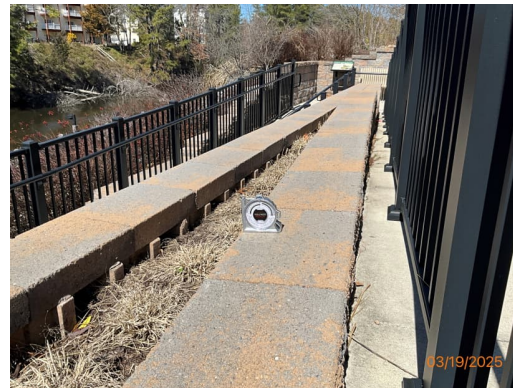
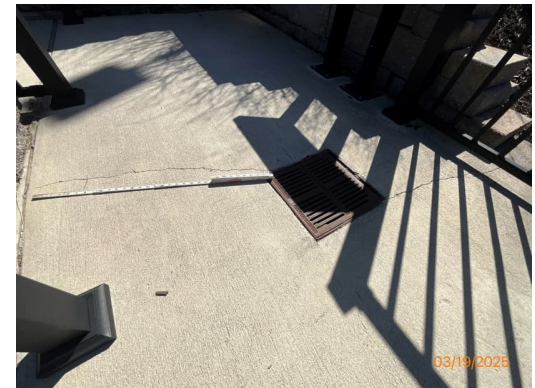
- At the transition from the walkway to the boardwalk, the concrete walkway exhibits differential settlement up to 1 1/4" high with respect to the boardwalk decking.
- Weephole on the east wall of Walkway #4 exhibits loss of fill and a missing cover.
- The west wall of Walkway #1 is rotated up to five degrees (5°) towards the canal and exhibits sagging up to 1" ± at this location.
- There is a full-width (6'-0") x up to 3/16" wide transverse crack in the concrete walkway around Inlet #3. Outlet pipe not observed during field visit.

- Continued monitoring specifically at the wall locations experiencing stair-stepping and/or bowing/sagging (~12-month duration)
- Identify/verify location of Inlet #3 outlet pipe and determine if repairs are necessary
- Consult with geotechnical engineer to ensure slope is stable enough for safe use of the GPCA and install Class R6 Riprap with reinforcing at the base of the wall (in concurrence with 2024 Geotech Report recommendations)
- Install ramp for smooth transition from concrete walkway to boardwalk

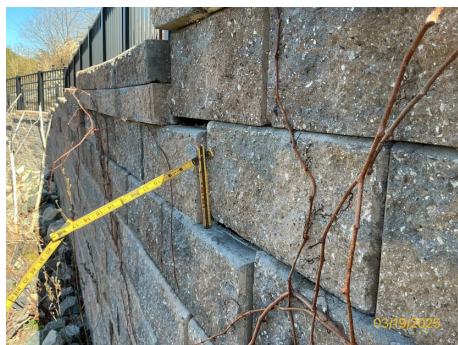
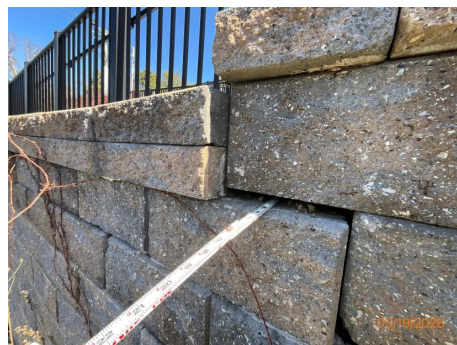
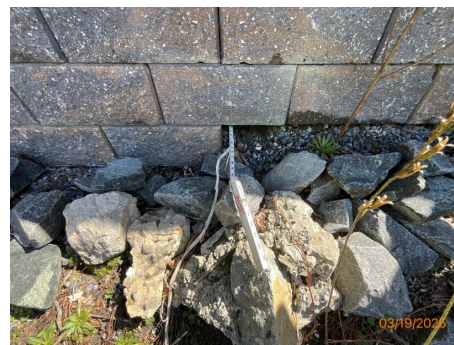
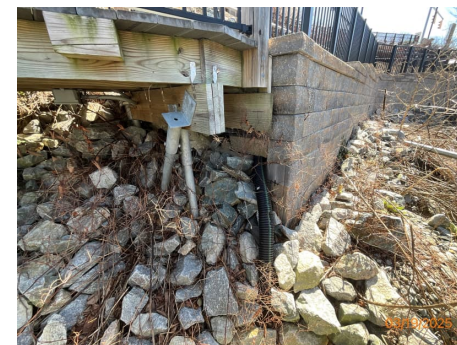
- Stair-stepping separation of the MBW blocks with vertical gaps up to 7/8" wide that can be probed up to 1'-0" deep at the south end of Wall #1 (Canal side).
  - At this location, the gravel foundation can be probed up to 8" deep and the ground embedment varies and does not meet the 1'-0" embedment standard.
- At the transition from the access ramp to the composite boardwalk there is a drainage pipe that is not shown on the Contract Plans but shown on as-builts.
