City of Rehoboth Beach Stormwater Implementation Plan

Phase III Results

December 2019

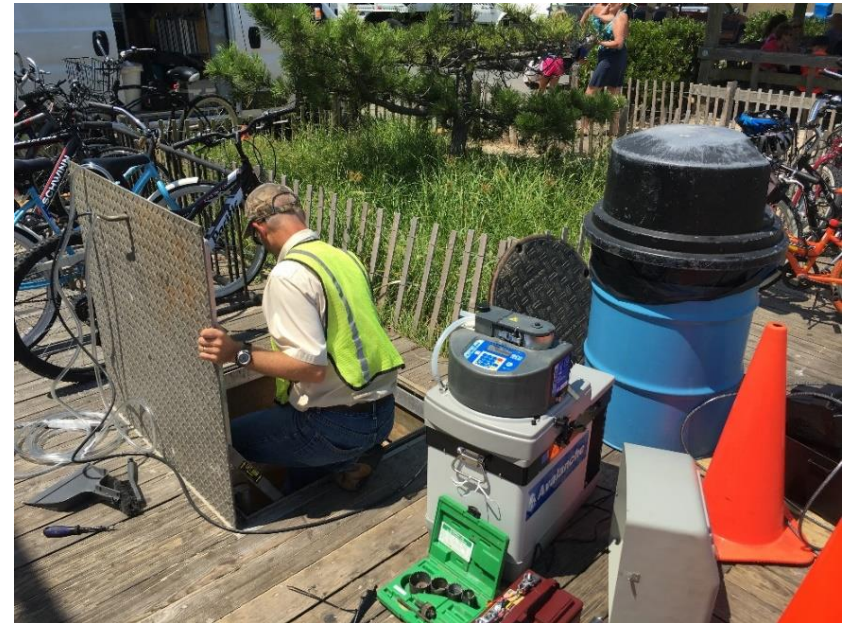
1. **Maintenance** & Clean-up

- ✓ Rehoboth Avenue vault cleaning and pump replacement
- ✓ Wilmington Avenue filter sand replacement
- ✓ Stormwater pipe cleaning
- ✓ CCTV

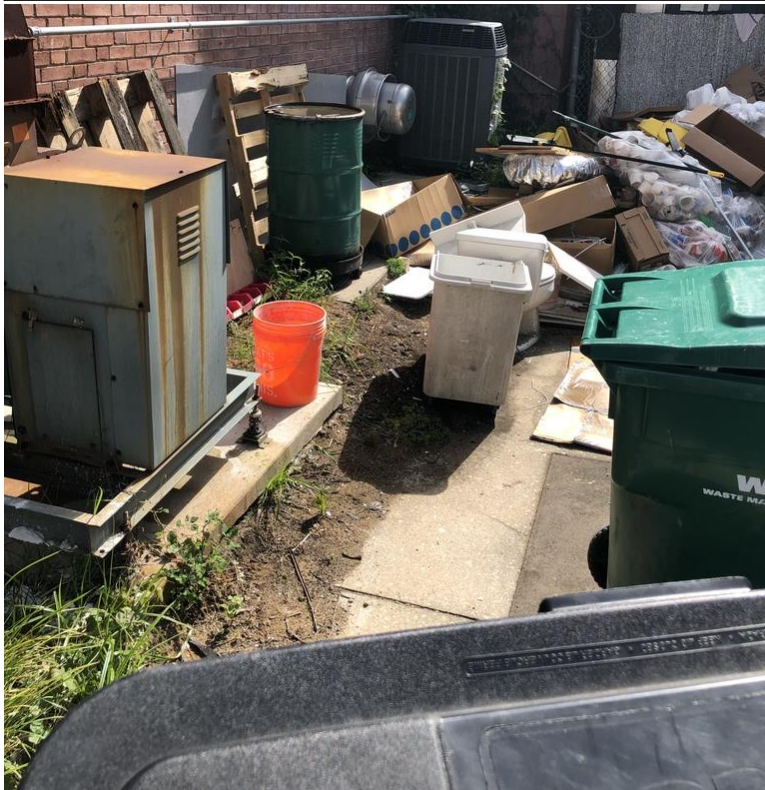
Trash and bird problems

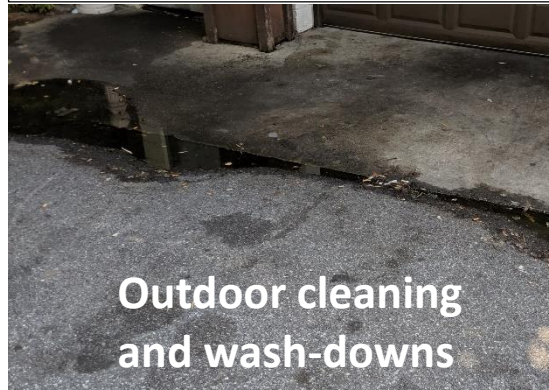
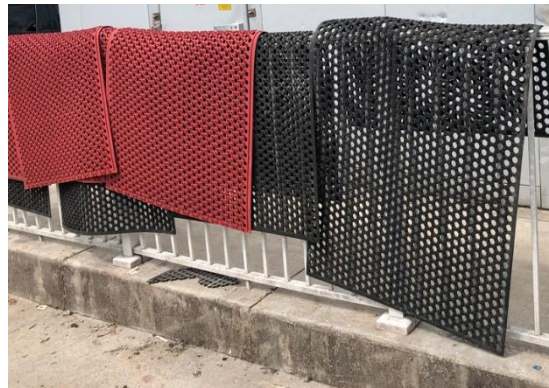
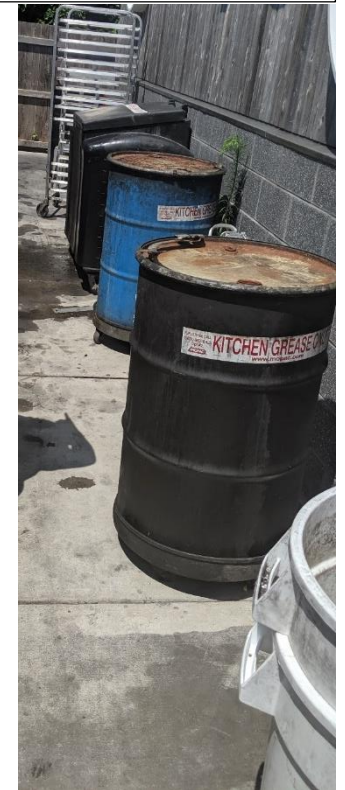
Poor housekeeping

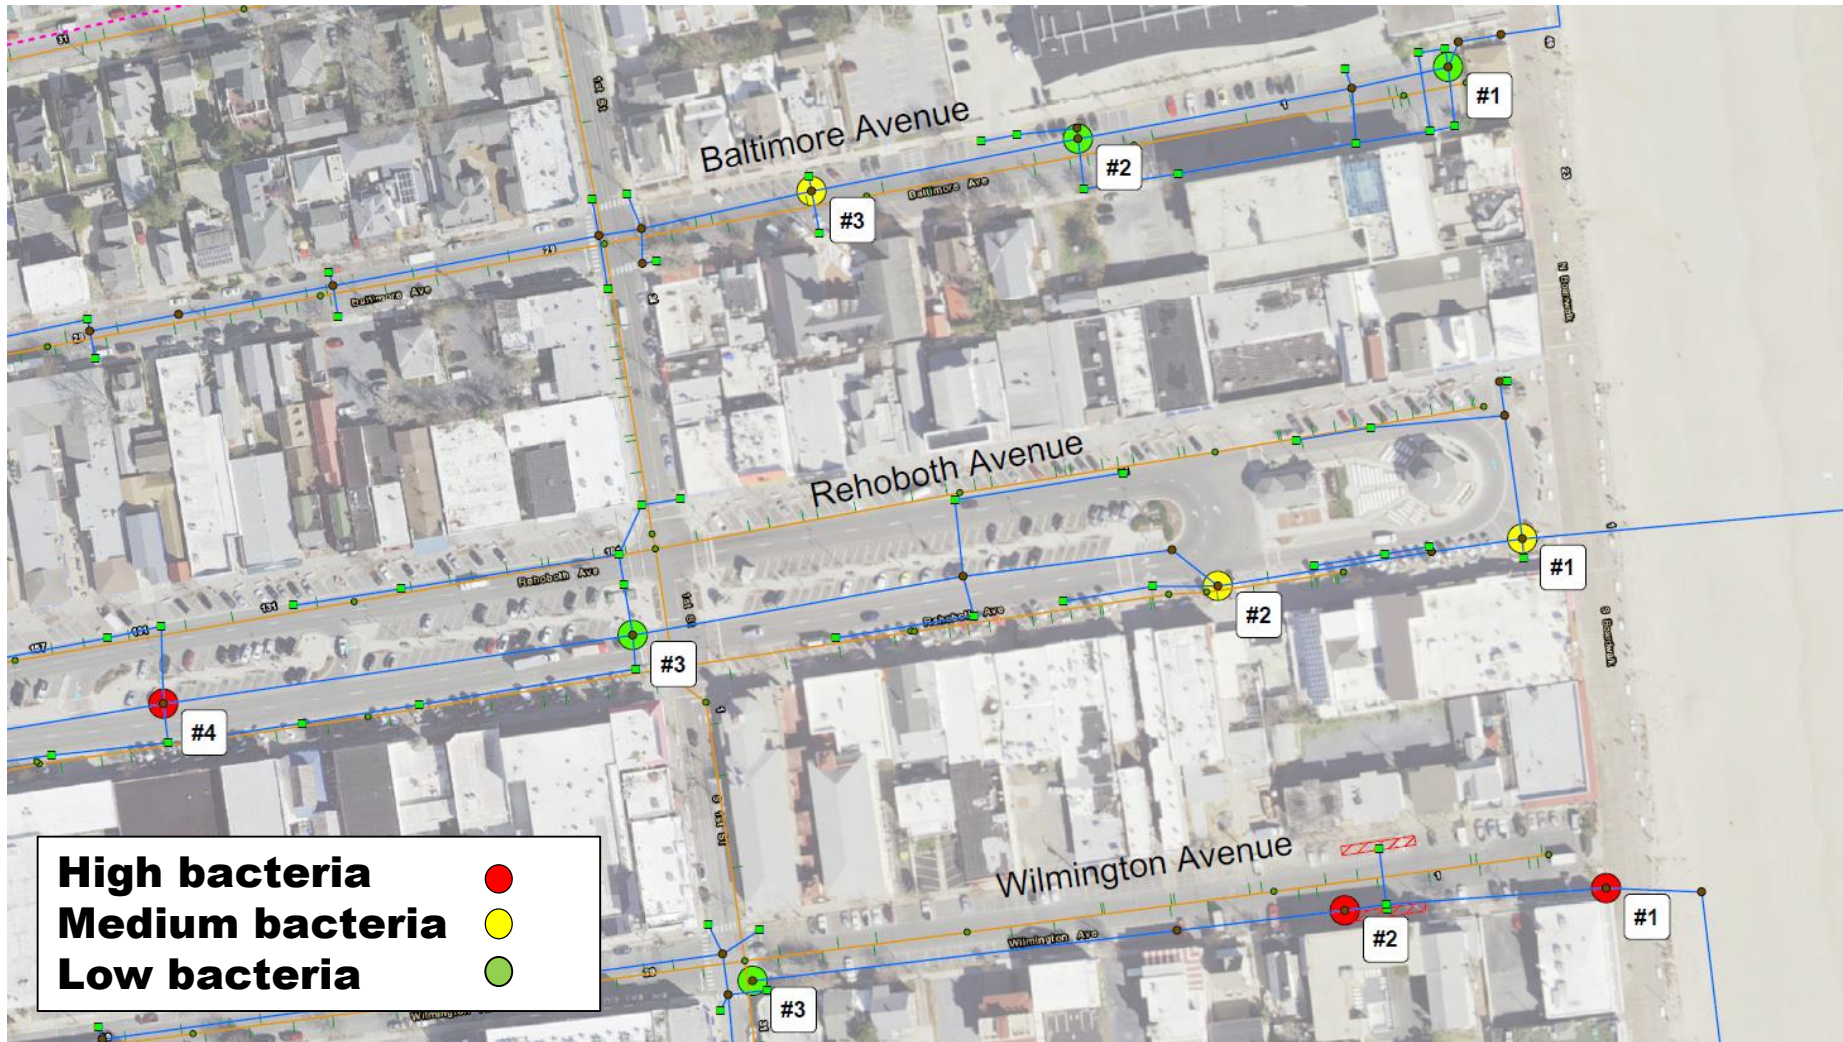
5. Determine Major Bacterial “hot spots”
